DTIC FILE COPY
MTL TR 88-48

CHEMICAL AND SURFACE CHARACTERIZATION OF TOW MISSILE CASES

SIN-SHONG LIN and WAI K. CHIN
MATERIALS SCIENCE BRANCH

December 1988

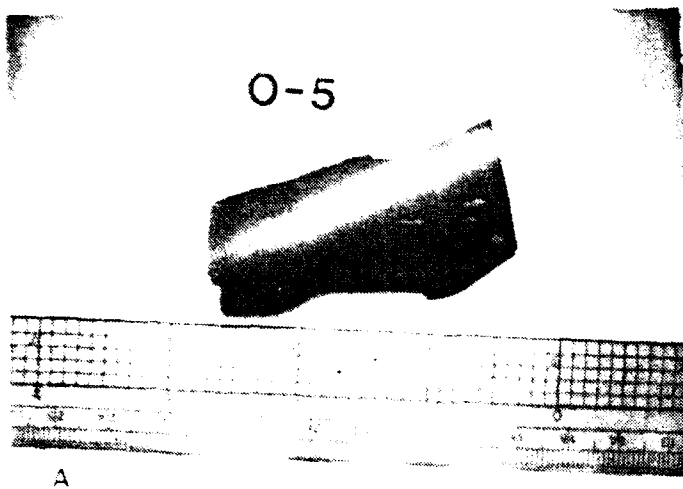
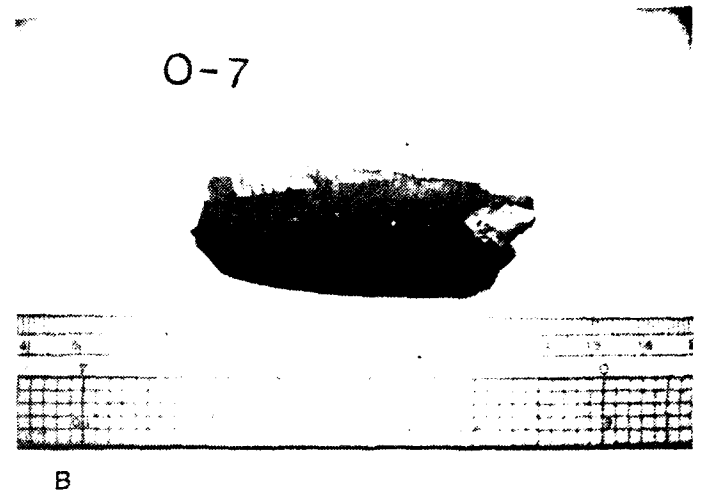
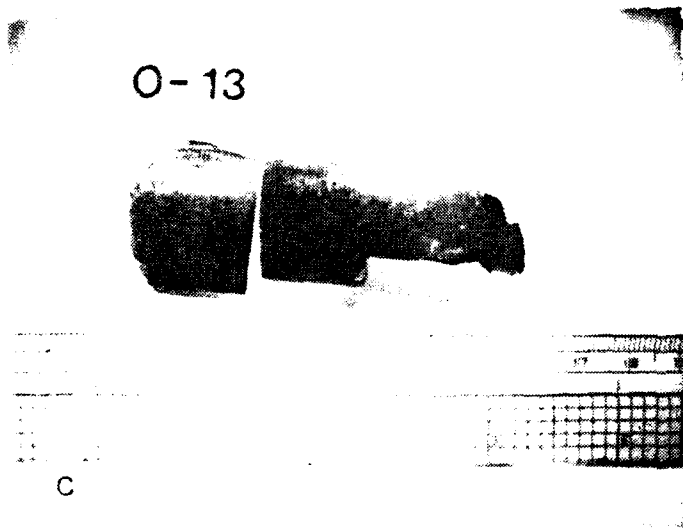
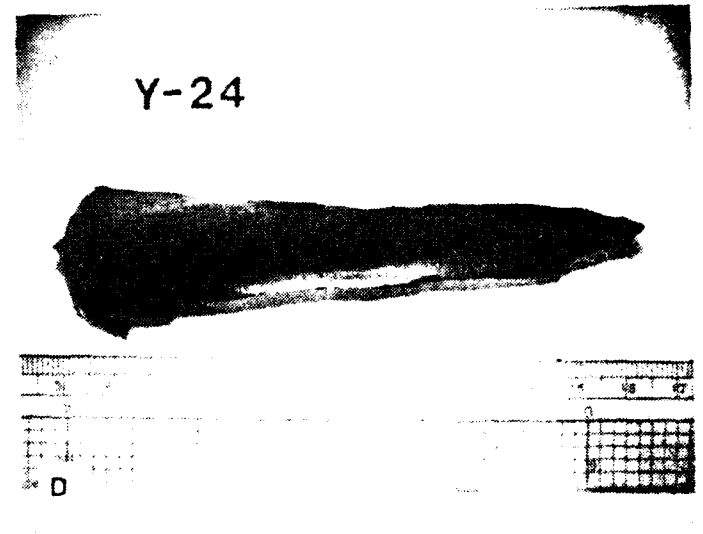
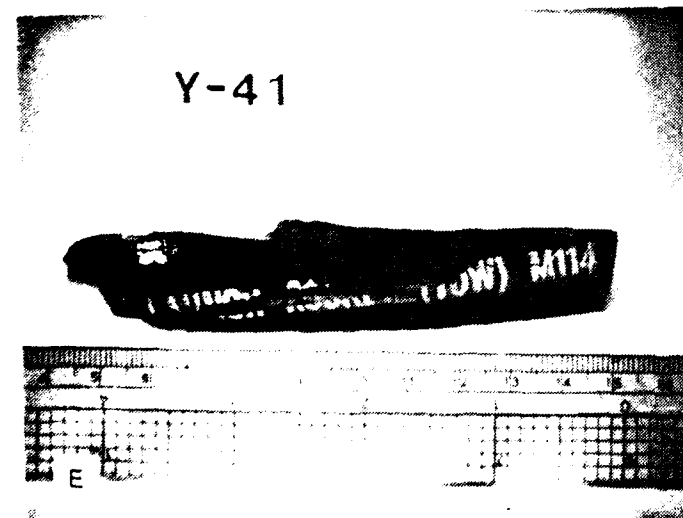
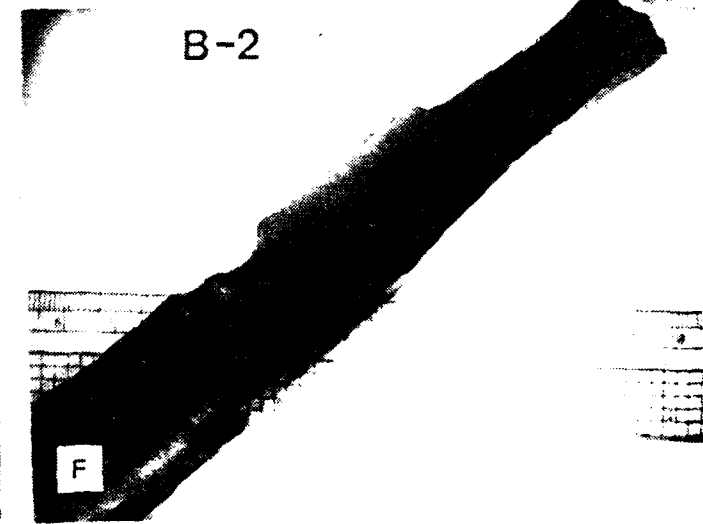
Six fragments from the failure missile cases were received (through the POC). The pieces were about 2 mm thick and 10 to 20 sq cm, weighing 15 to 30 g, and identified as O-7, O-5, O-13 (Oahu failure); Y-24 and Y-41 (Yakima failure); and B-2 (Blanket test, reference). The sizes and shapes of these pieces are shown in Figure 1.

Figure 1. Fracture pieces from missile case failure. Six samples were received from three sources: Cahu, Yakima and Blanket test reference). (a) #O-5 (b) #O-7 (c) #O-13 (d) #Y-24 (e) #Y-41

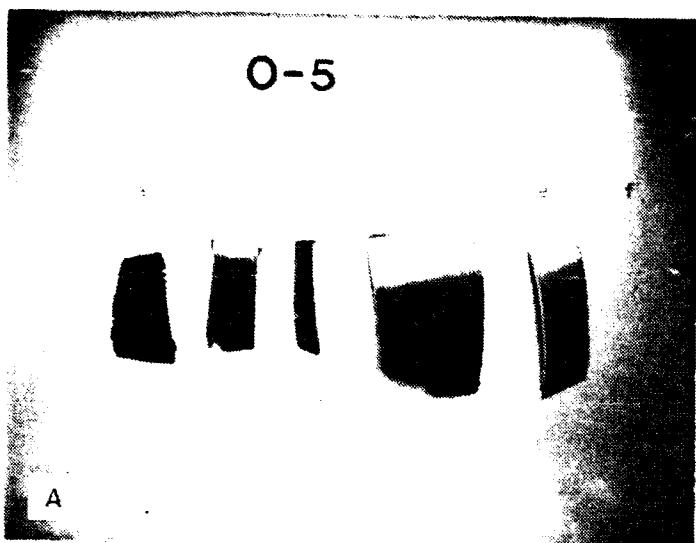
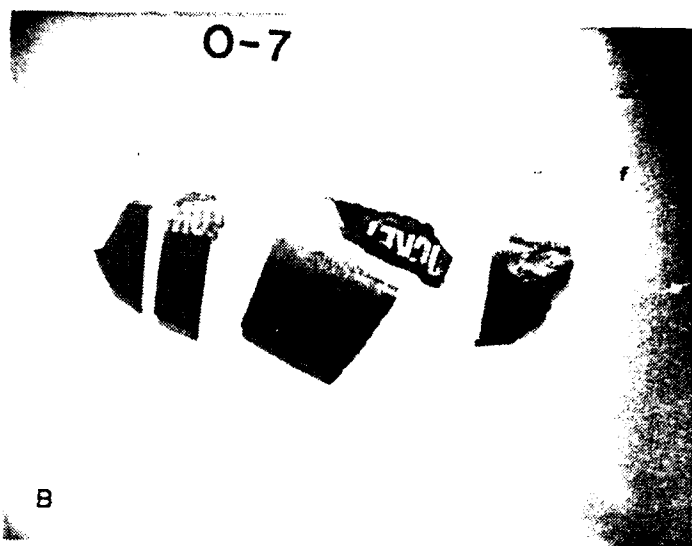
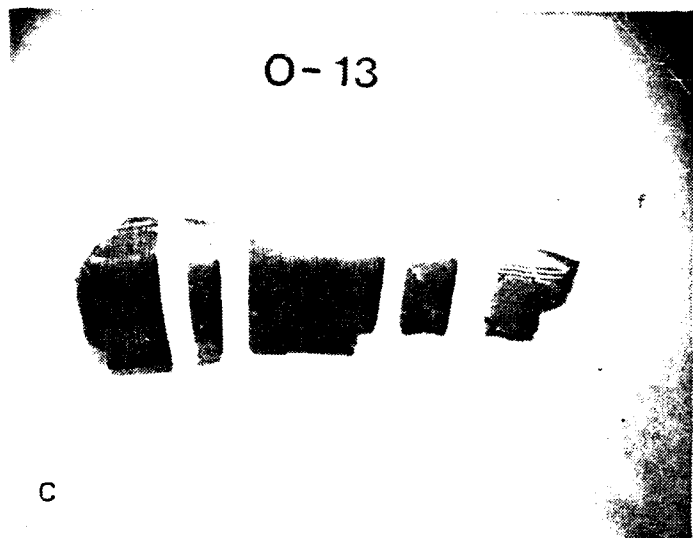
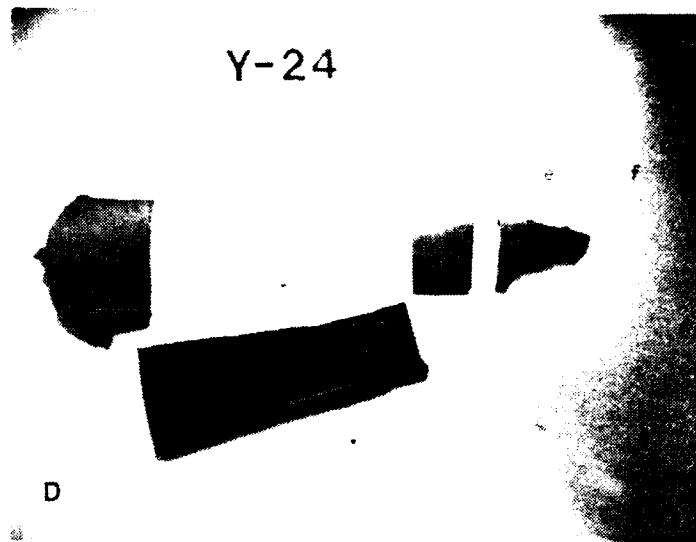
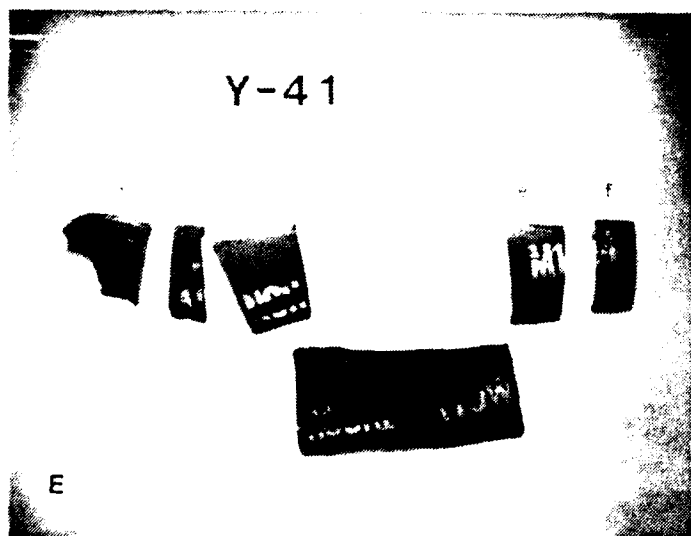
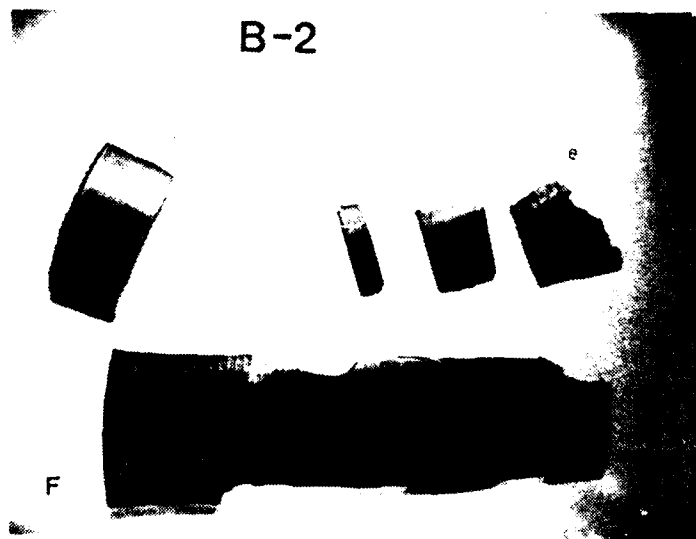
For analytical purposes, these pieces were cut by a Si C saw blade into several small pieces as shown in Figure 2. The cut pieces are tagged by a letter following their identification. The end cuts which have irregular sizes and large fracture surfaces, are generally reserved for uses in OM, SEM, and SAM surface studies, and the large cuts are used for quantitative chemical composition analyses. For the latter analyses, the pieces are further chipped and ground by the MTL machine shop. The distribution of the cut specimens for analyses is tabulated in Table 1.

Figure 2 Specimen shapes and sizes after preparation (a) #O-5 (b) #O-7 (c) #O-13 (d) #Y-24 (e) #Y-41 (f) #B-2.
